AFTERMATH OF "PABLO" STORM

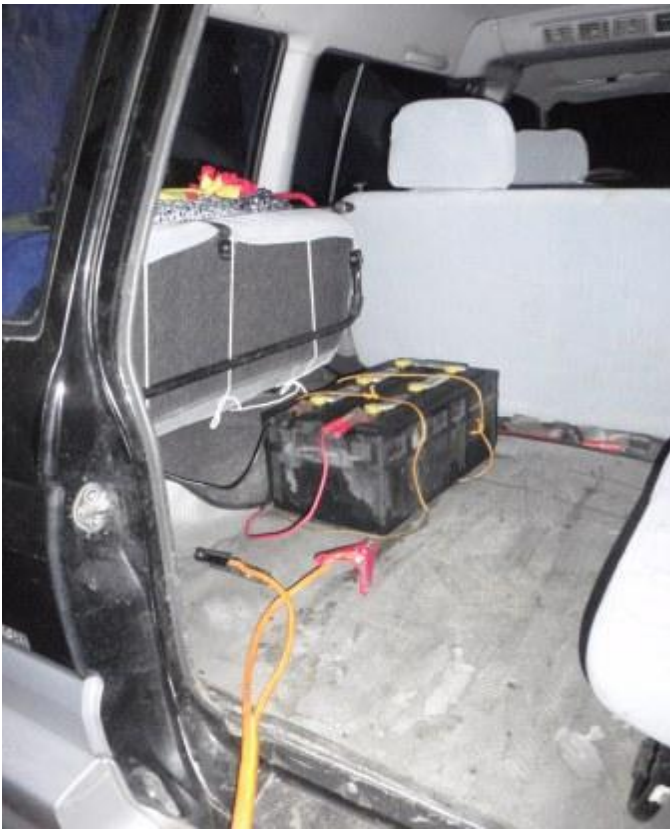
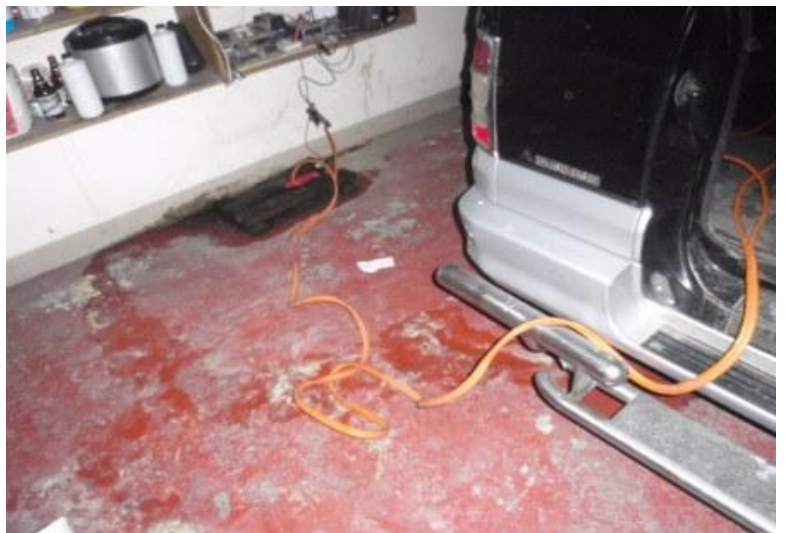
On left, huge battery was loaded on van and wired up to van's battery in engine compartment. Then jumper cables (above) are used to connect battery combo to inverter in garage. This was so that I could charge the big battery when driving around, then use it to power the house at night. But power came back in 24 hours rather than 4 days as originally indicated.

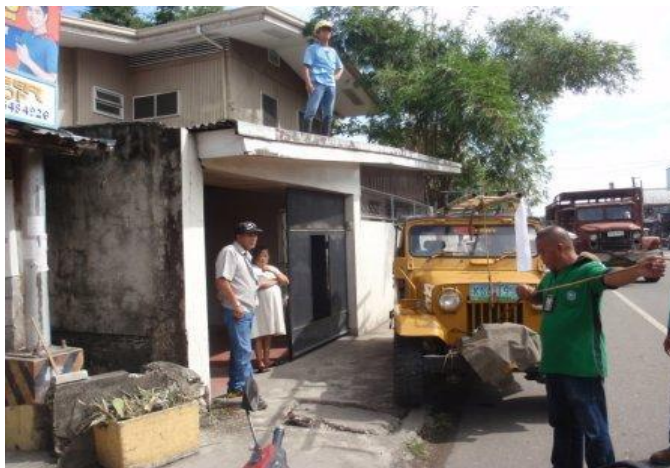
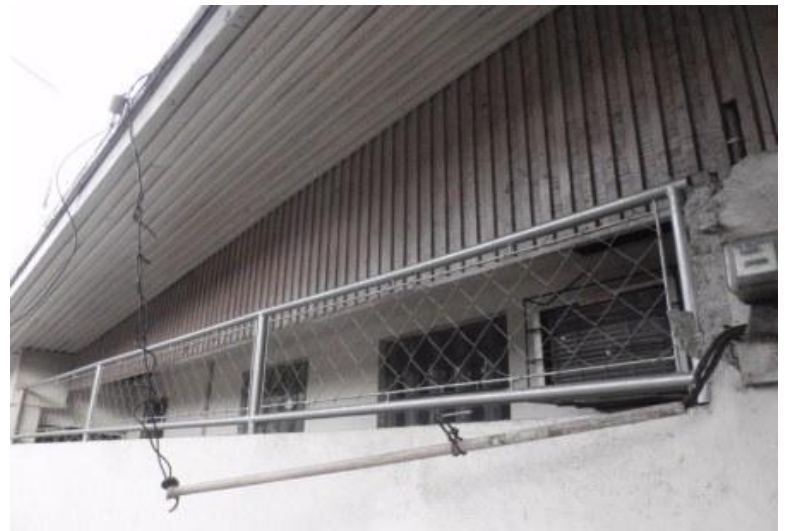
Above, Noreco repairing power line to the house, which had been ripped off by passing truck at height of storm, shown above. Original line was copper, which apparently was stolen right away. Noreco suggested we purchase on our own a 30 meter aluminum line which is standard nowadays, which we did as it cost only P560. Theoretically, we could have insisted that Noreco supply the wire themselves, but that would have caused more delay due to requisitioning etc. Tipped them big.
